Technical Data Sheet <u>Manchester Model 8361, 8362 Primary Air Control Fix</u>

Kit number 93-87610

<u>Read This Before You Begin</u>: The failure which results in a seized air control handle is caused by a hole drilled out of tolerance. The replacement Push Rod accounts for this machining variance.

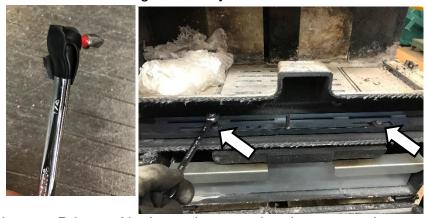
8) The mounting screws are now accessible for the Primary Air Shutter. A short screwdriver, or a Philips driver bit in a ¼" wrench is necessary to remove the screws. Remove the damaged Primary Air Shutter.

9) Install the new Primary Air shutter by reversing the process in step 8. If hardware is damaged during removal, replacement screws and washers are provided in the kit. Apply anti-seize to the back face of the shutter where it contacts the cast iron. The roller portion of the air shutter should be assembled as seen in the picture below. Note: the hex lock nut must be tightened against the back face of the roller mounting face to ensure the roller does not come loose during use.
